Broken River Restoration Project

Phase 1 – Site Selection Report

Broken River Restoration Project - Site selection field trip report

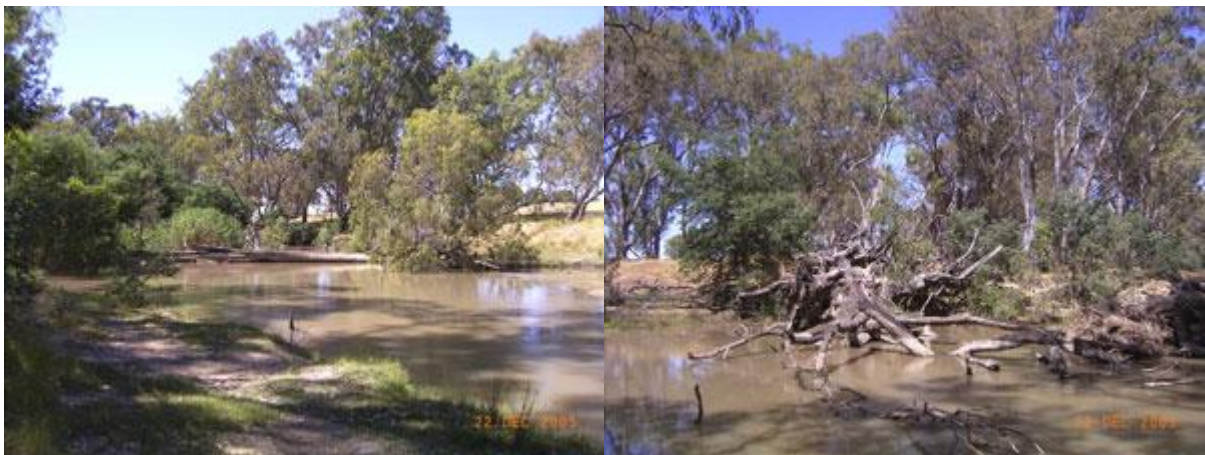
Quinn Road

Site	GDA datum	Wood	Instream habitat	Riparian zone	Other
Quinn Rd	S 36027.911' E 145054.111'	Poor	Less diverse	Upstream is similar to <i>Mokoan Park</i> ; reasonable	Elements of all levels; straight
Goomalibee Bridge	S 36027.688' E 145051.706'	Old		Good but thin	Snags on site from previous stabilisation works; incised channel
Ballintine Rd	S 36027.330' E 145048.516'	Not much		OK	Sinuuous
Burnells Rd	S 36026.601' E 145046.255'	Very old, decayed; very little; small, no LWD		Bushland reserve; decent; trees with grass	Previous stabilisation works
Dairy Rd	S 36025.582' E 145042.906'	Poor		Thin; inside bend better; not much understorey	Single large bend
Shack	S 36025.891' E 145039.668'	Poor		Poor; poplars	
Cosgrove Rd	S 36025.520' E 145037.896'				Higher flow
Fothergills Rd	S 36025.676' E 145036.668'			Great	Well vegetated islands; faster flow; braided; loads of <i>Phragmites</i> ; <u>different to all other sites</u>

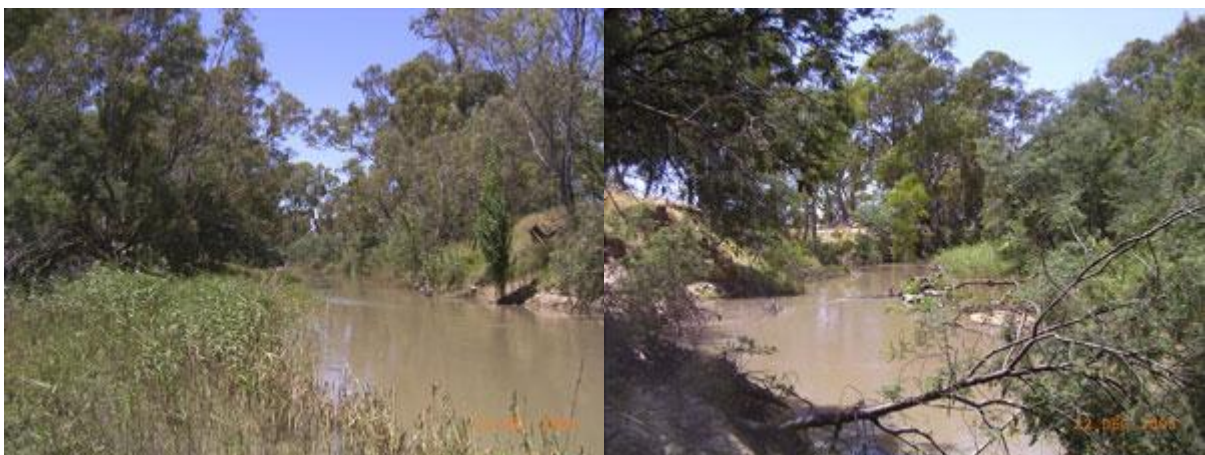
Pine Lodge Road

Keats Rd	S 36025.757' E 145035.734'	None		Average/good especially on inside bend	Timber piles into bank for stabilisation
Pine Lodge Rd	S 36025.397' E 145031.653'	Not much,	Lots in higher flow	Good	Everything good except LWD
